WORK ORDER DONE

Ship CARNIVAL TRIUMPH

Object DIESEL GENERATOR # 1

WO Subject DIESEL GENERATOR, HIGH TEMP SPOT CHECK

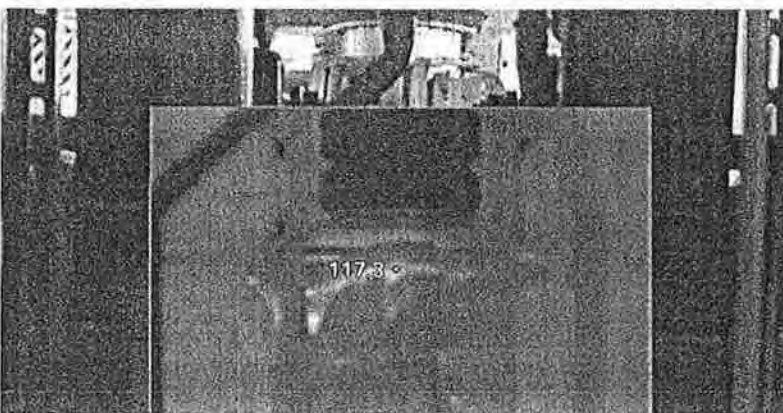
D / G # 5 Hot Spot Free

Infrared Thermographs (IRT) Manufacturer : FLUKE, Model: T110 ;

Contact Probe thermometer Manufacturer : FLUKE , Model 52 II

Emissivity is set by manufacturer at 0.95

Load 79 % Environment air Temperature 43°

The Diesel generator # 5, has been found hot spot free
